TO: Alaska/Richardson/Steese Highways Corridor Action Plan (A/R/S CAP) Project Files

DATE: 1 August 2023

SUBJECT: Stopping Sight Distance Analysis for Bus Stops on ARS Corridor Task 5

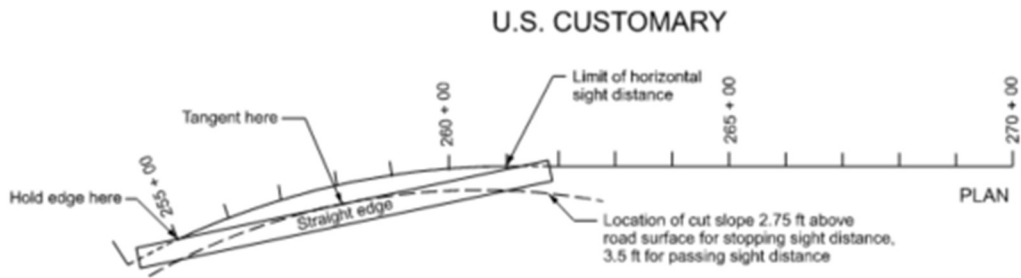
SSD on horizontal curves is controlled by any obstruction to a driver's sightline on the inside of the curve. Sight restrictions may be caused by signs, cut slopes, vegetation, buildings, or any other roadside object. Snow buildup during the winter can also restrict horizontal sightlines for drivers in shorter vehicles. Figure 2 illustrates the method to determine horizontal sight distance from the plan view for any point along the roadway, including compound curves, using a straightedge. SSD is typically measured from the middle of the traveled lane to the middle of the inside lane of the curve.

Figure 2: Green Book illustration of method for measuring horizontal sight distance (AASHTO, 2018)

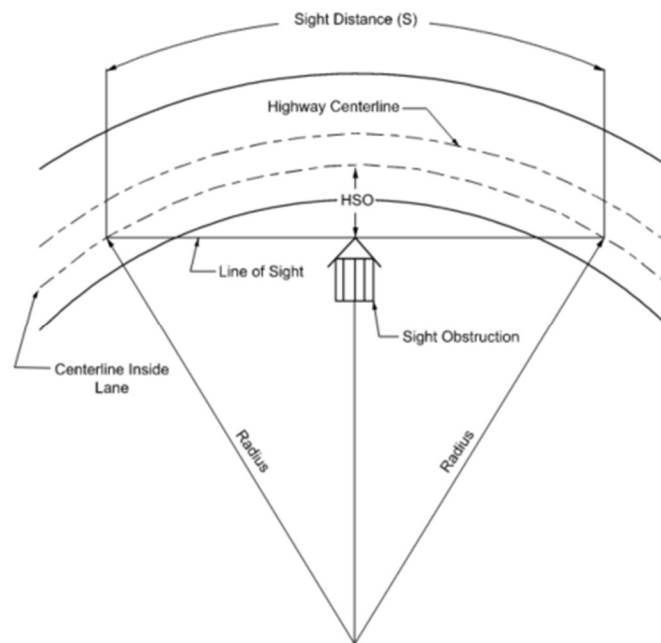
Figure 3: Green Book diagram illustrating the components of horizontal sight distance (AASHTO, 2018)

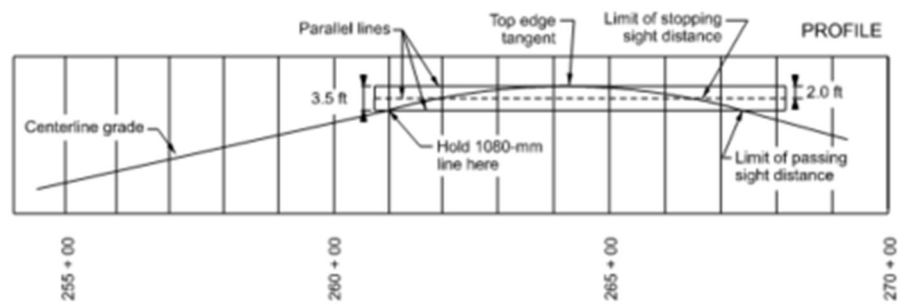
Sight distance on vertical curves is controlled by the sight line obstruction due to the vertical profile of the roadway. Figure 4 shows the process of determining SSD on crest vertical curves using the centerline profile and a straightedge.

Figure 4: Green Book method for measuring vertical sight distance (AASHTO, 2018)

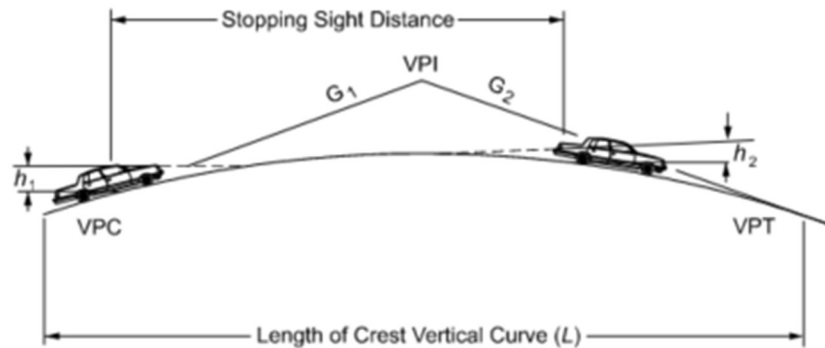
Figure 5: Green Book crest vertical curve SSD diagram (AASHTO, 2018)

The GB criteria for SSD on vertical curves is based on sight distance for crest vertical curves (**Error! Reference source not found.**) and headlight sight distance at night for sag vertical curves. There is no sight restriction in daylight on sag vertical curves. Crest vertical curve length when sight distance is less than the curve length ($S < L$) and when sight distance is greater than crest vertical curve length ($S > L$) is determined by:

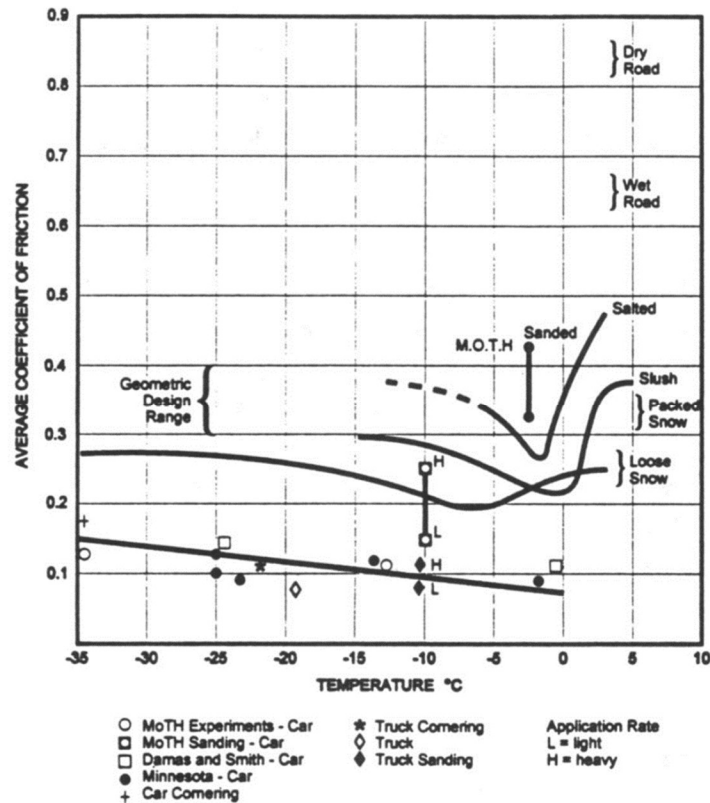
Figure 6: Coefficient of friction in winter conditions from Vehicle Traction Experiments on Snow and Ice (Navin, 1996)

Design values from the current GB edition account for suboptimal road conditions (e.g., wet or dirty pavement) by using conservative design values. The design deceleration rate of 11.2 ft/s/s is the 10th percentile value for all passenger cars in dry conditions. Outdated GB versions used the tire-pavement friction factor (f) to calculate SSD but supplied no specific f values for winter conditions. Research into friction factors for vehicles on ice yielded a range of values (Figure 6) from the Society of Automotive Engineers experimentation (Navin, 1996). A friction factor of 0.1 at -10°C was determined to represent the available traction and is used in SSD for icy

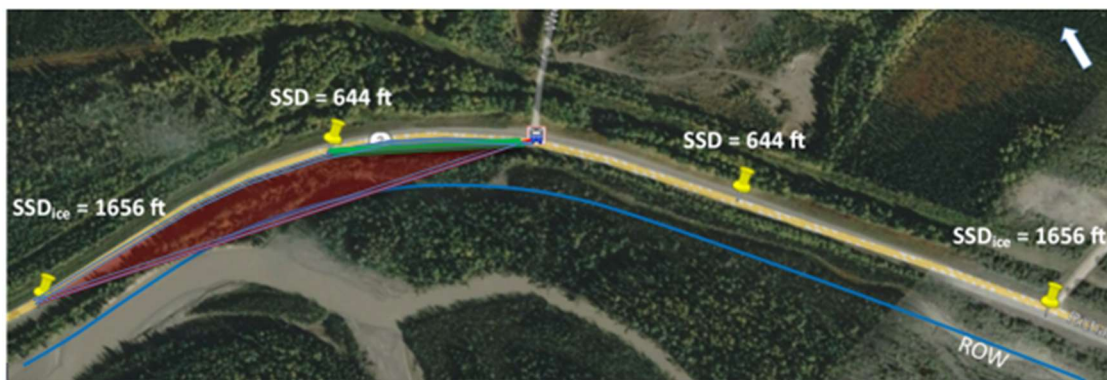
SSDs for these stops were compared with sight restrictions along the curve. As an example, Figure 7 shows the AASHTO design and snow/ice SSDs in the southbound direction for the FNSBSD bus stop on Richardson Highway at Wrong Way Lane. The sightline for the design SSD of 644 ft is shown as the green chord. The green shaded area between this chord and the traveled path is free from obstructions so horizontal sight distance is acceptable. The red chord shows the sightline required for the 1656 ft SSD in snow/ice conditions. The red shaded area between the chord and the traveled path would need to be fully cleared for adequate sight distance. The blue line depicts the available right of way to the inside of the curve.

Figure 7: FNSBSD Richardson at Wrong Way Ln bus stop location

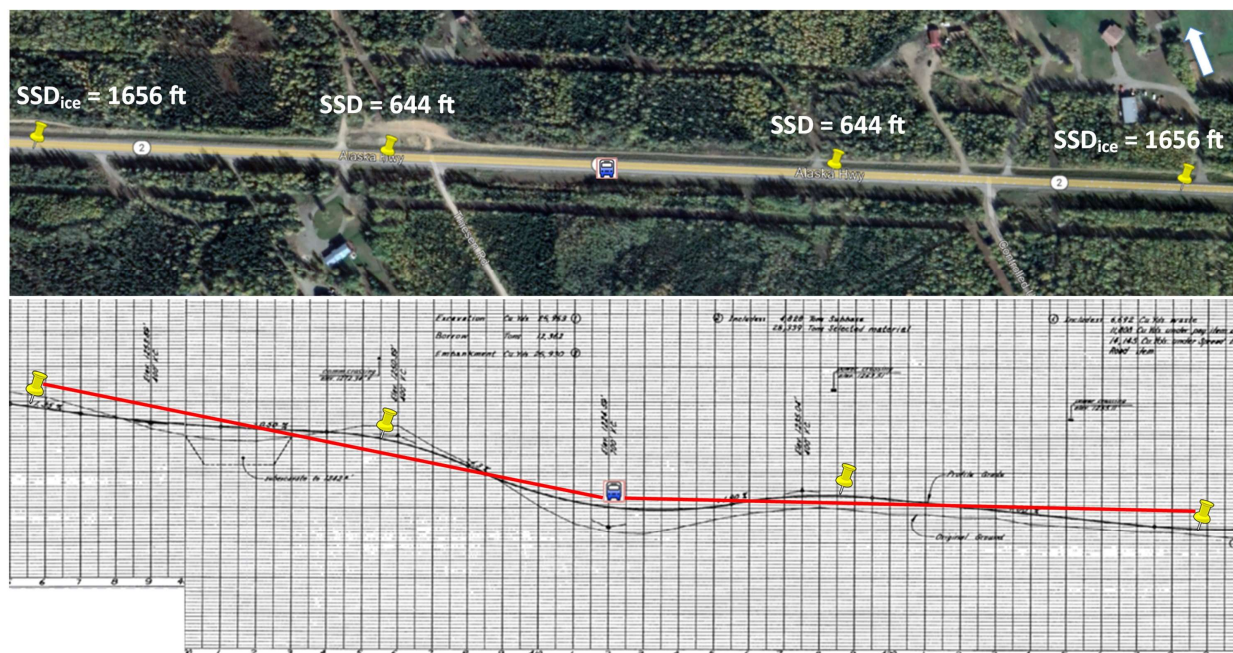
This stop is located on a 700 ft long sag vertical curve. There is 400 ft crest vertical curve (northbound grade change from 1.00% to -1.90%) immediately south and a 400 ft crest vertical curve (northbound grade change from 4.30% to 0.50%) immediately north. This location was verified by DGSD but as of a 6/29/23 DGSD communication this is no longer a bus stop.

Figure 11: DGSD Alaska Highway at Fleet Street bus stop location

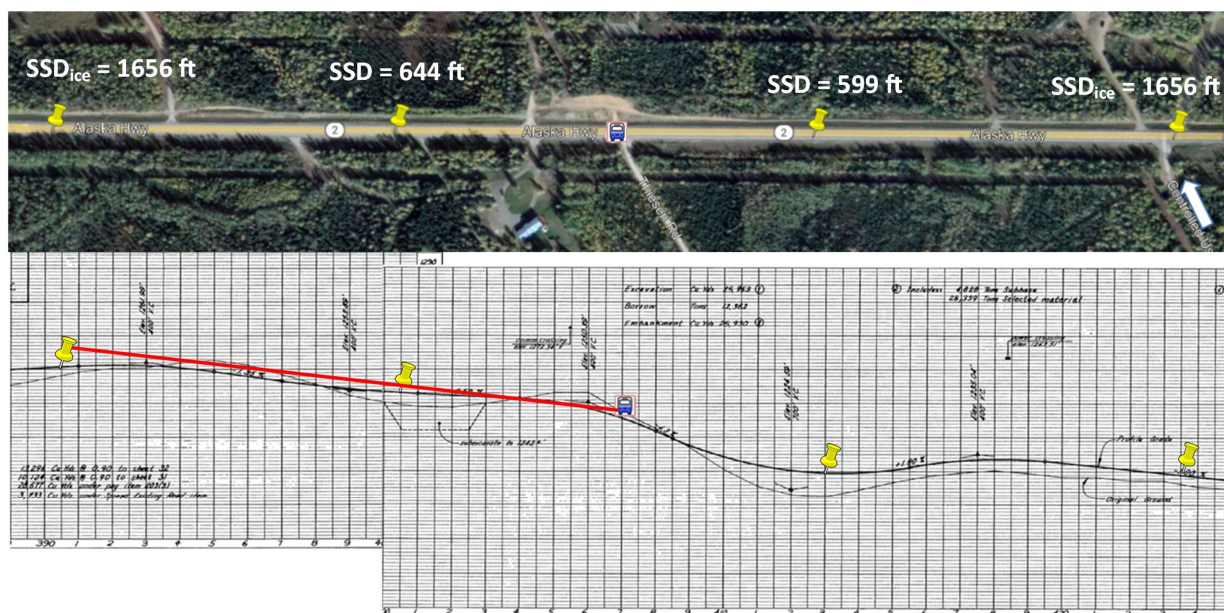
This stop located on a 400 ft crest vertical curve with the grade changing from 4.30% to 0.50% in the northbound direction. There is a 700 ft sag vertical curve (grade changes from -1.90% to 4.30%) and a 400 ft crest vertical curve (grade changes from 1.00% to -1.90%) to the south of the stop. A 400 ft sag vertical curve (grade changes from 0.50% to 1.35%) precedes a 400 ft crest vertical curve (grade changes from 1.35% to -0.50%) to the north of the stop. The bus stops in the roadway for both directions of travel.

Figure 12: DGSD Alaska Highway at Theisen bus stop location

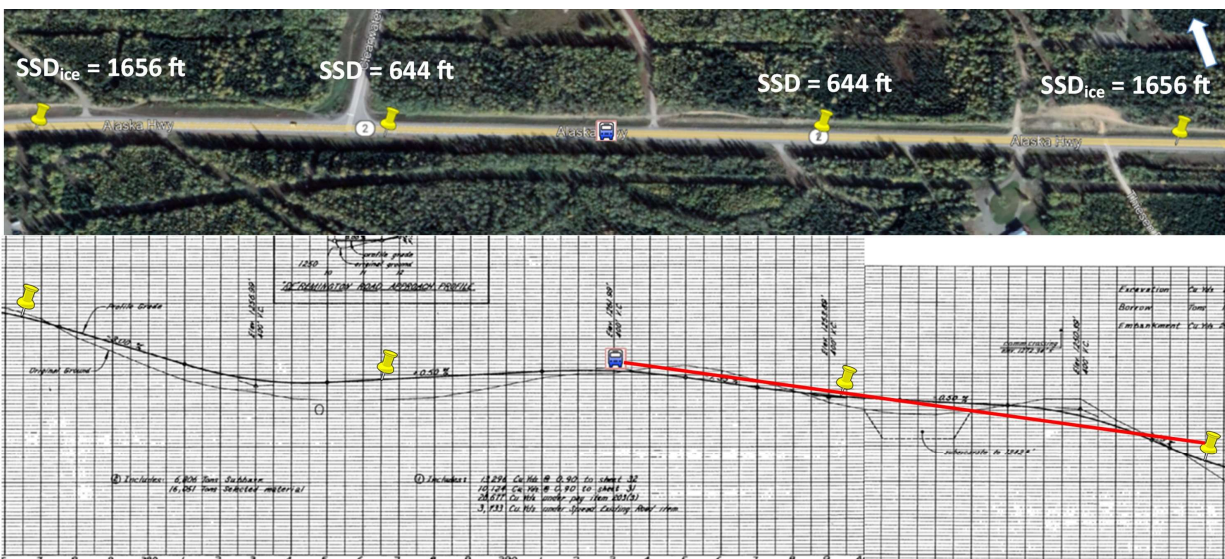
This stop is located on a 400 ft crest vertical curve (northbound grade changes from 1.35% to -0.50%). There is a 400 ft crest vertical curve (northbound grade change from 4.3% to 0.50%) to the south and 500 ft crest vertical curve (northbound grade change 3.0% to -0.18%) to the north. It is approximately 1300 ft south of a 925 ft long horizontal curve with a radius of 2865 ft. Buses stop in both directions on the roadway.

Figure 14: DGSD Alaska Highway at MP 1414.7 bus stop location

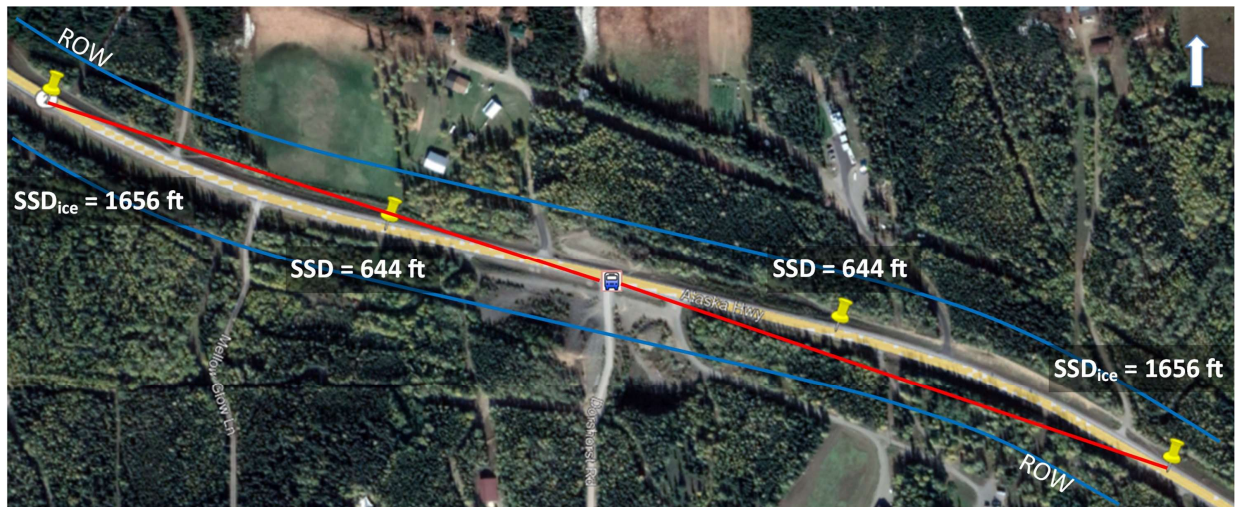
This stop is located approximately 700 ft south of an 1172 ft horizontal curve with a radius of 2865 ft and approximately 700 ft north of a 925 ft long horizontal curve with a radius of 2865 ft. The bus stops in the roadway in both directions of travel. As of 6/29/23 DGSD communication this is no longer a stop.

Figure 15: DGSD Alaska Highway at Dorshorst Road bus stop location

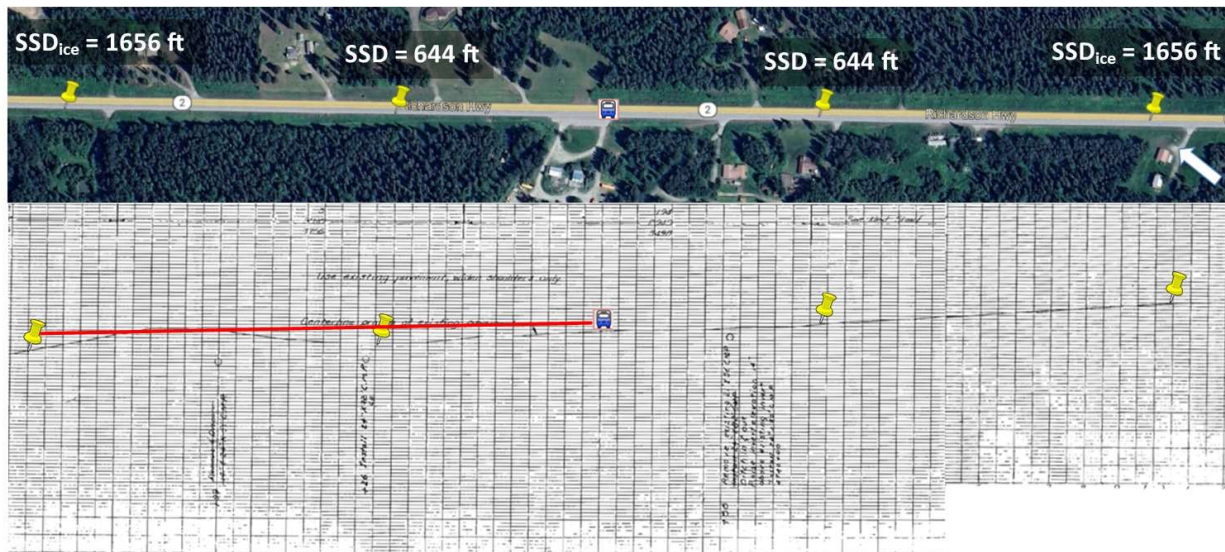
This location is approximately 1100 ft south of a 400 ft vertical curve (northbound grade changes from 0.60% to -1.50%). The bus stops in the roadway in the northbound direction only. As of 6/29/23 DGSD communication this is no longer a stop.

Figure 20: DGSD Richardson Highway at Krebs Lane bus stop location

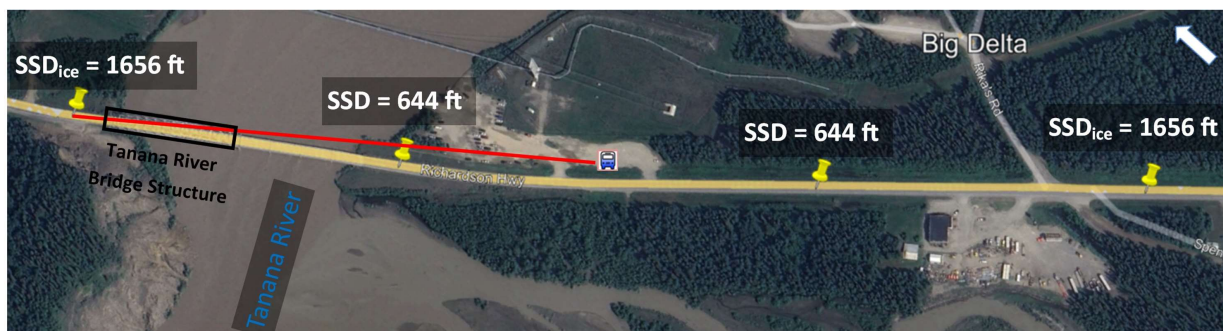
This location is on an approximate 10000 ft radius tangent just south of the Tanana River bridge off the roadway. Sight distance analysis was conducted at location of the stop.

Figure 21: DGSD Richardson Highway Old Gas Station Stop at Bridge bus stop location

The speed limit should be reduced to 50 mph to meet current design standards for SSD while crossing the bridge. Sight distance should be reevaluated after the existing bridge is replaced.

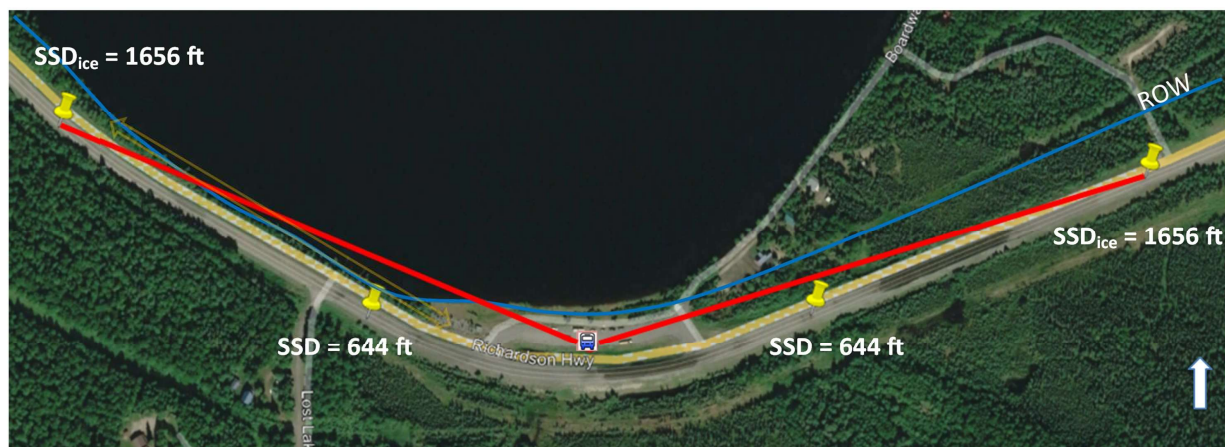
The bus stop is located at a pullout on the inside of a 1045 ft long horizontal curve with a radius of 1146 ft. The bus stops off the roadway in both directions. Sightline analysis was completed where the bus stops within the turnout. The right-of-way to the north of the pullout is limited to approximately 100 ft on each side of the roadway centerline depending on the location of Birch Lake.

Figure 24: FNSBSD Richardson Highway Birch Lake pullout bus stop location

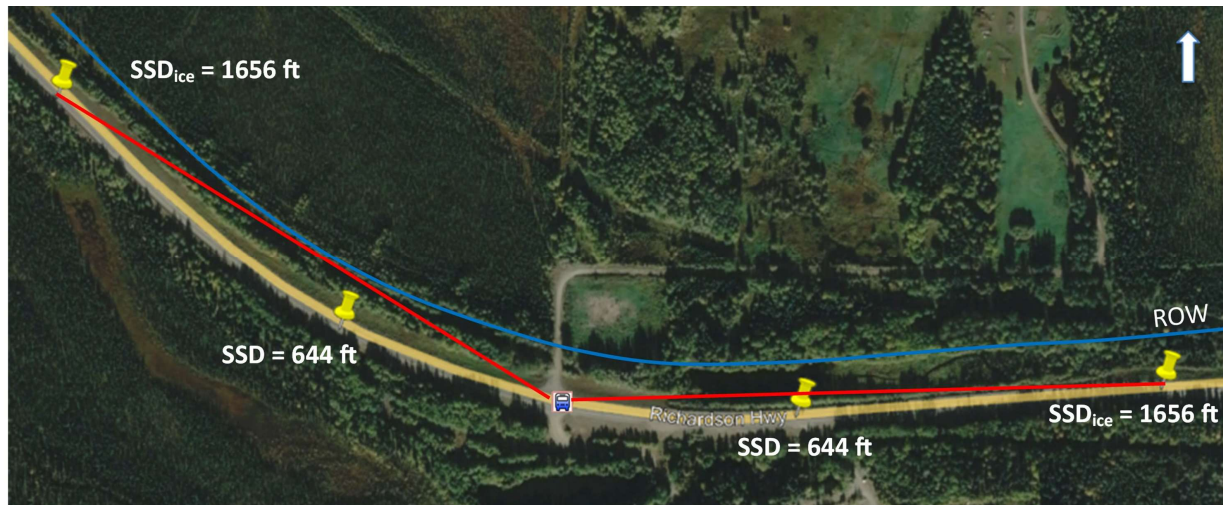
This stop is located on a level grade, 1985 ft long horizontal curve with a radius of 2292 ft. The bus stops in the roadway for pickups in the southbound direction. Vegetation is not currently cleared from behind the guardrail located just off the northbound shoulder leading up to the stop.

Figure 25: FNSBSD 12005 Richardson Highway bus stop location

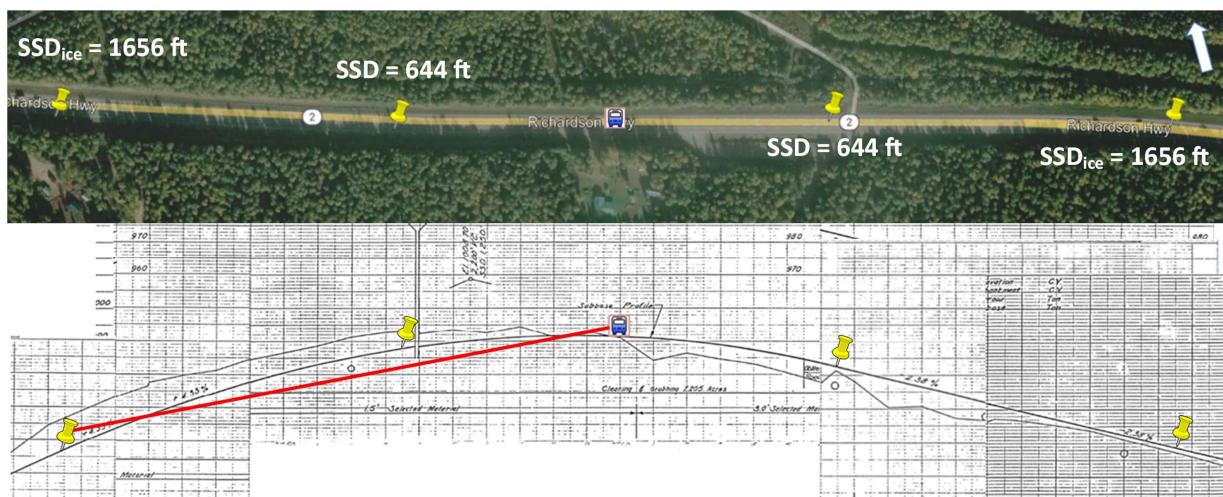
The bus stop is in an undivided highway passing lane segment with two northbound and two southbound lanes located 350 ft south of the point of intersection for a 2200 ft long crest vertical curve (2.38% to -4.33% grade in northbound direction). There is a 790 ft long horizontal curve with a radius of 11460 ft to the north and a 727 ft long horizontal curve with a radius of 5730 ft to the south. The bus only makes a southbound stop on the roadway.

Figure 27: FNSBSD 11899 Richardson Highway bus stop location

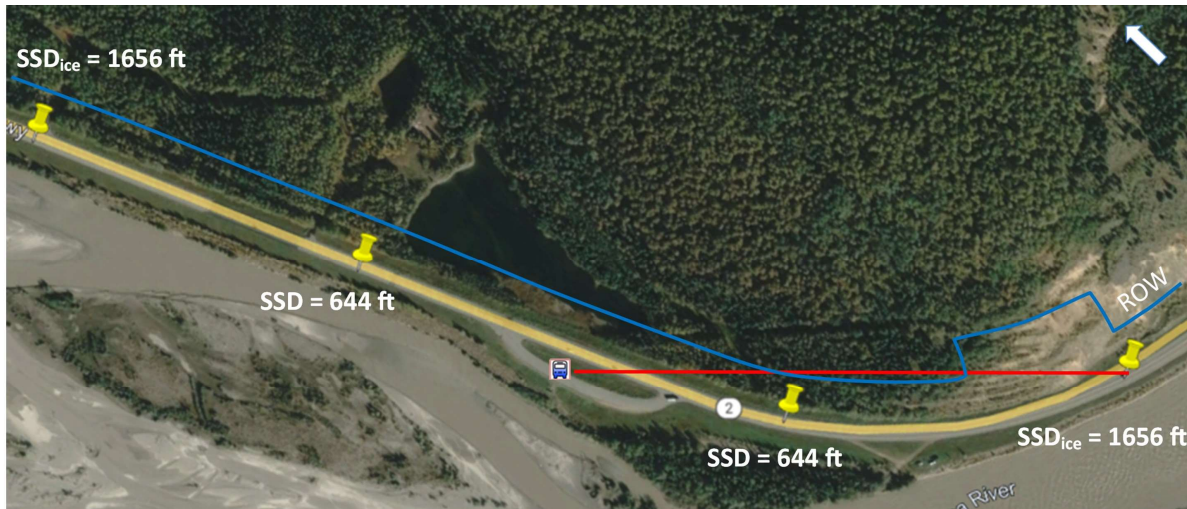
This bus stop is in a turnout approximated 400 ft from the end of a 2595 ft long horizontal curve with a radius of 1528 ft. The sightline traveling northbound is restricted by a rock face and vegetation. Buses utilize the pull out traveling in both directions. Sight distances were determined from the bus stop position in the turnout.

Figure 28: FNSBSD Richardson Highway at state pull out bus stop location

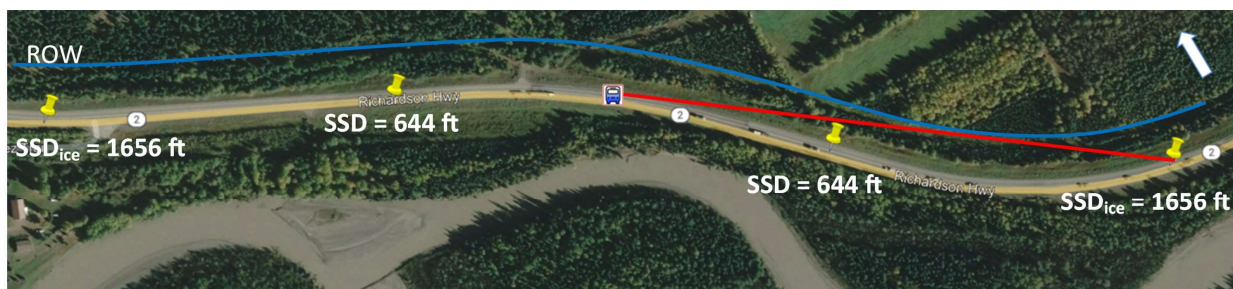
This stop is located on a 781 ft horizontal curve with a radius of 2292 ft. A 1435 ft long horizontal curve with a radius of 1435 ft begins approximately 1000 ft to the south. Only one bus stops in the northbound direction on the roadway.

Figure 29: FNSBSD 10536 Richardson Highway bus stop location

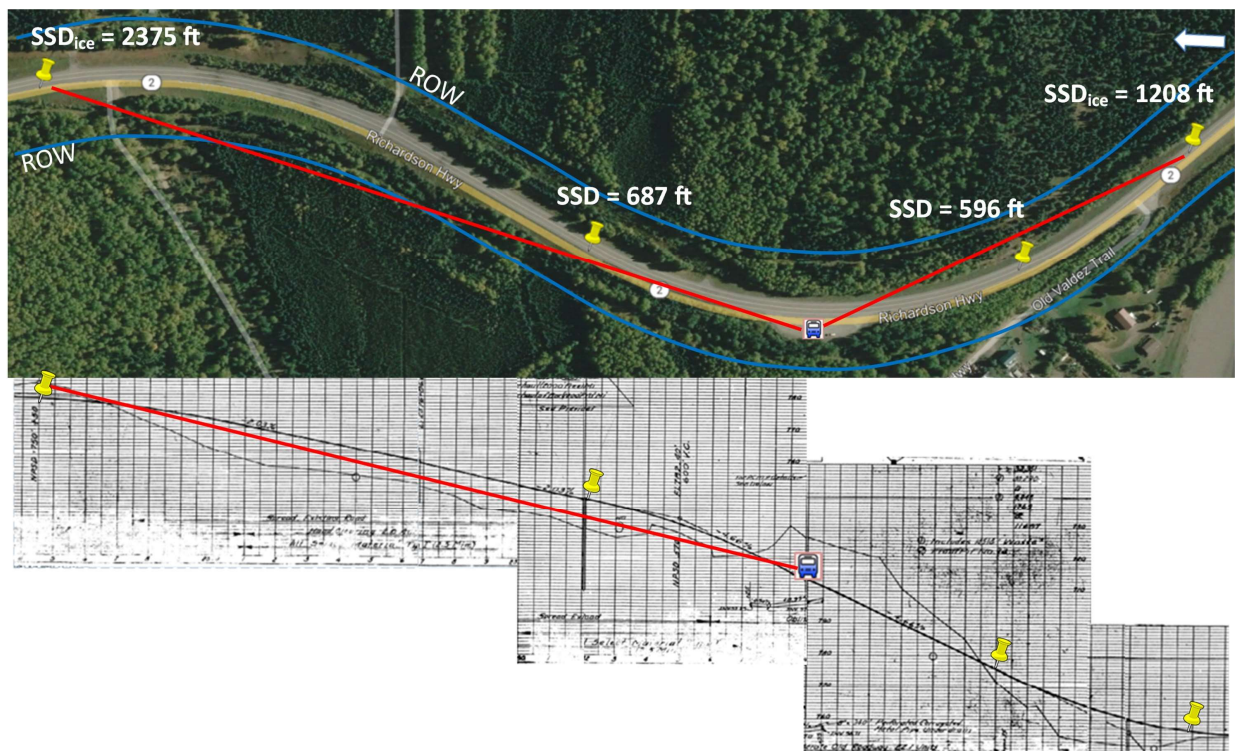
Stop is located within turnout 300 feet south of a 600 ft crest vertical curve PVI (-2.03% to -4.66% in southbound direction). The stop is on the outside of a 1617 ft long horizontal curve with a radius of 1348 ft. The speed limit is 65 miles per hour. Sight distances determined from the bus stop location in the turnout. A 1423 ft long horizontal curve with a radius of 1637 ft begins approximately 1250 ft north of the stop. Buses stop in the turnout for both directions of travel.

Figure 30: FNSBSD Richardson Highway at Salcha Scenic Turnout bus stop location

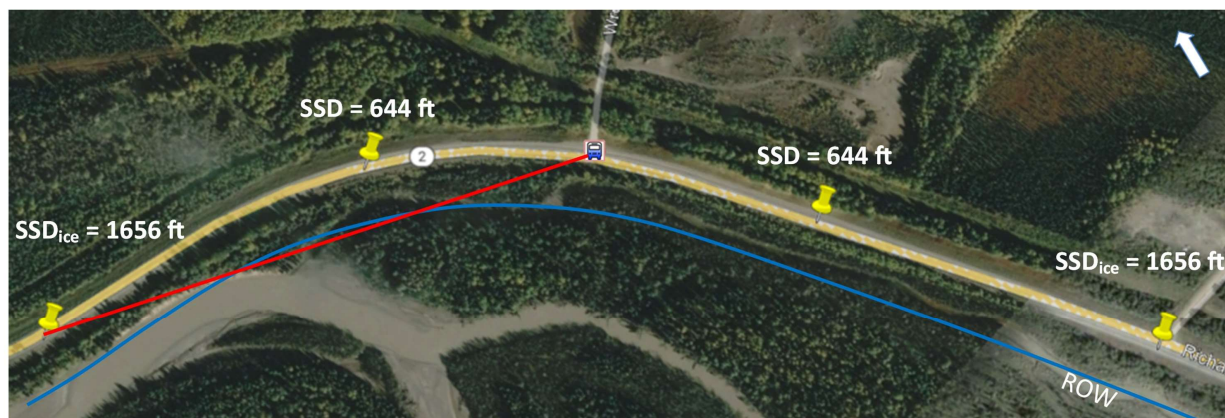
The stop is located on a level grade, 1468 ft long horizontal curve with a radius of 1637 ft. The stop is in the roadway for both directions of travel.

Figure 31: FNSBSD Richardson Highway at Wrong Way Lane bus stop location

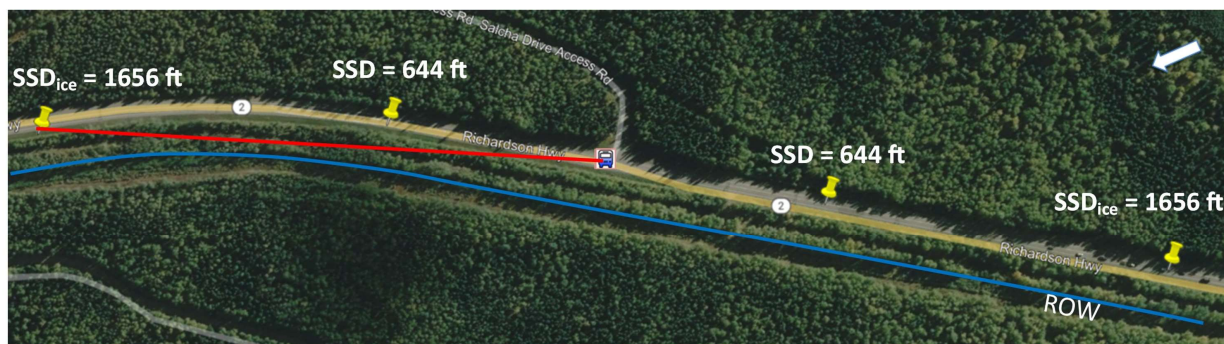
This stop is located on a tangent 600 ft south of a 993 ft long horizontal curve with a radius of 2865 ft. The bus stops in both directions on the roadway.

Figure 32: FNSBSD Richardson Highway at Salcha Drive South bus stop location

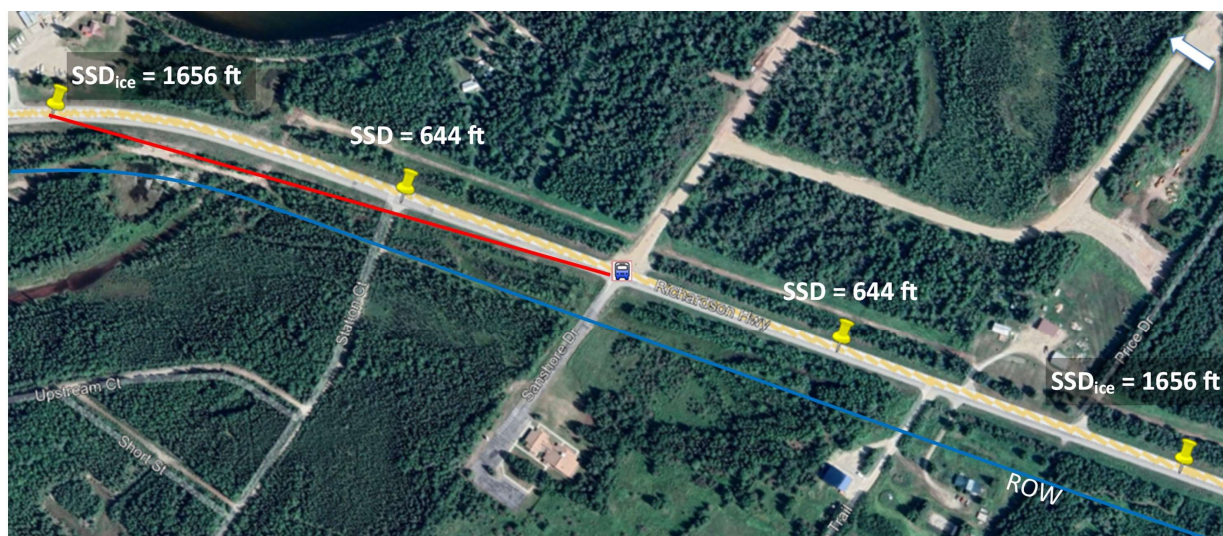
The bus stop is located on a tangent approximately 1000 ft south of a 1558 ft long horizontal curve with a 1637 ft radius. Student pick up and drop off occur within the roadway for both directions of travel.

Figure 33: FNSBSD 9207 Richardson Highway LDS Church bus stop location

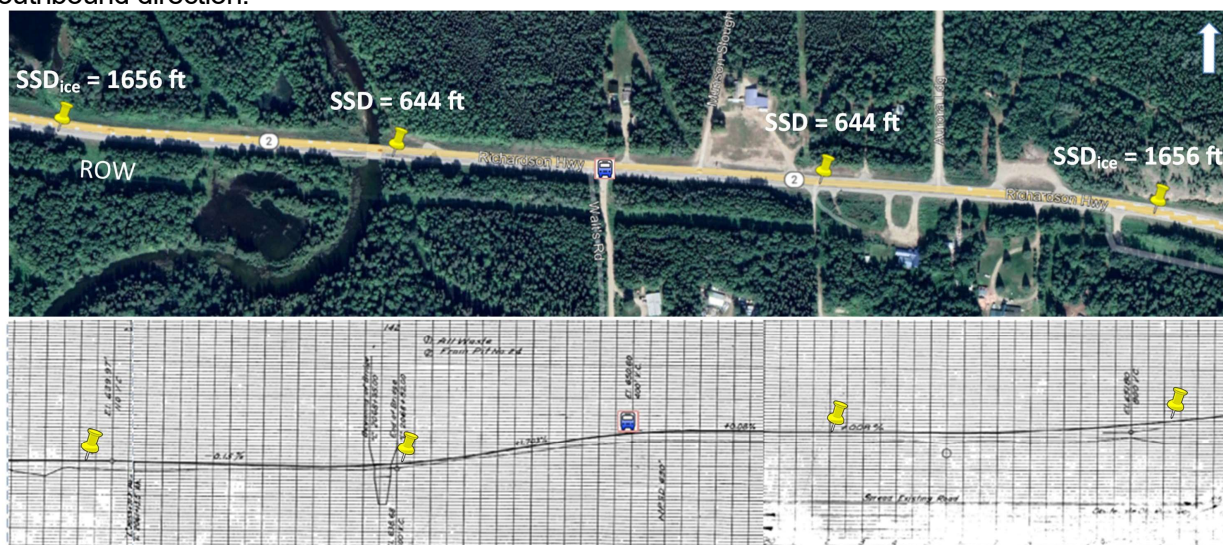
This stop is located on a 400 ft long crest vertical curve (1.70% to 0.08% change of grade in the southbound direction). It is 1350 ft north of a 794 ft long horizontal curve with a radius of 2865 ft. One daily stop is made in the southbound direction.

Figure 36: FNSBSD 8810 Richardson Highway at Walts Road bus stop location

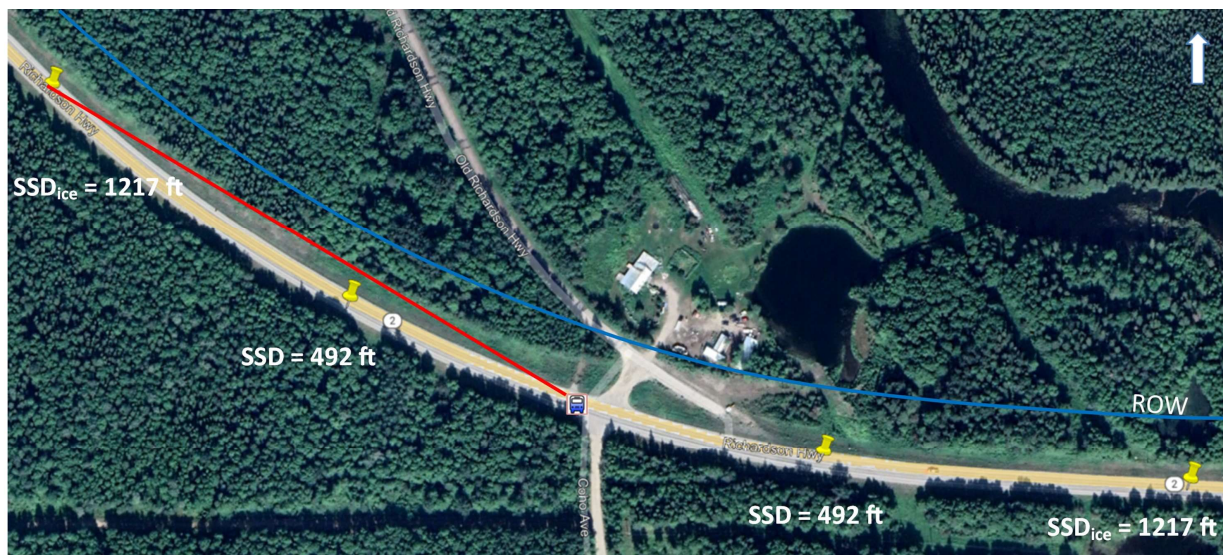
This stop is located on a 2096 ft long horizontal curve with a radius of 2865 ft. Buses stop in the roadway in each direction of travel. The speed limit changes 550 ft south of the stop location.

Figure 37: FNSBSD Richardson Highway at Old Richardson Highway bus stop location

Field inspection should be conducted at this location to verify available sight lines. It is recommended to remove an additional 5 ft of vegetation on the inside of the curve. Excessive vegetation growth between maintenance would likely obstruct the required sightline if the current clearance offset remained unchanged.

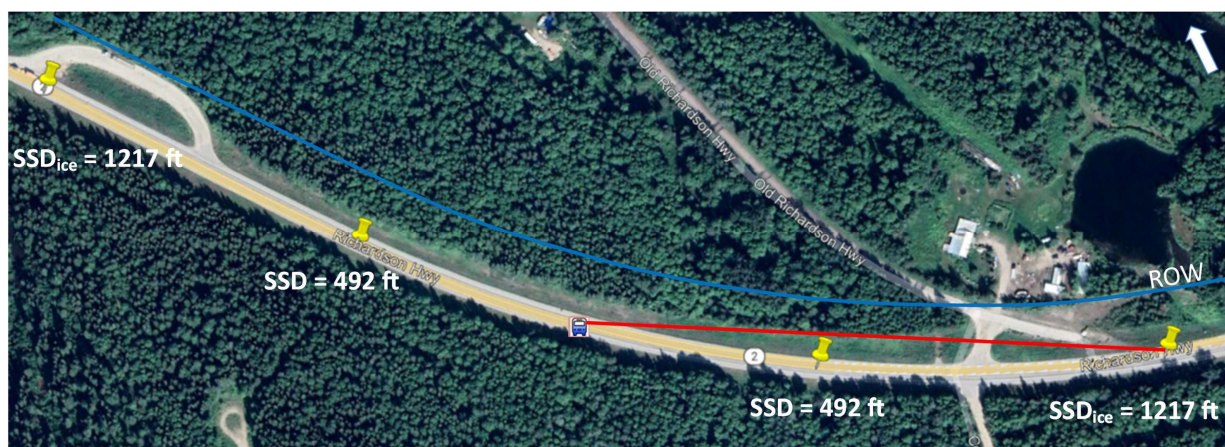
This stop is located on a 2096 ft long horizontal curve with a radius of 2865 ft. The bus stops on the roadway in both directions of travel.

Figure 38: FNSBSD 8750 Richardson Highway bus stop location

It is recommended to increase vegetation clearance by five feet to ensure required sightlines are met between maintenance clearing or to decrease the speed limit to 50 mph.

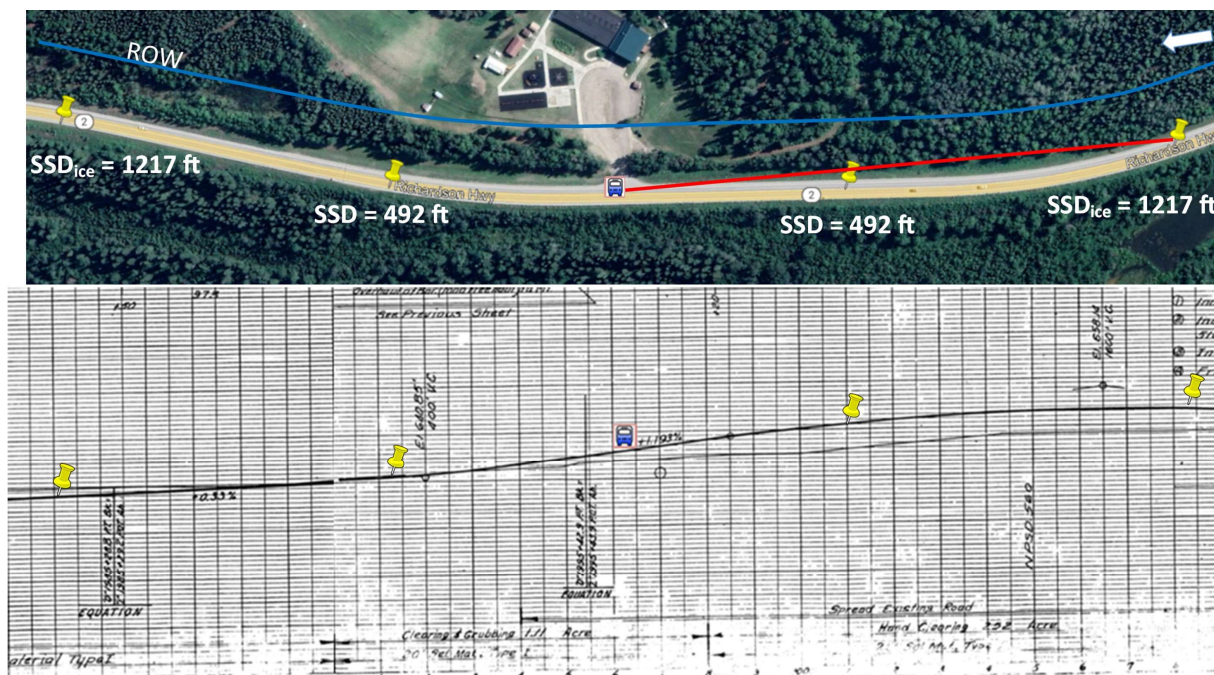
This stop is located 200 ft north of a 1600 ft long crest vertical curve (1.21% to -1.19% grade change in the northbound direction). An 1856 ft long horizontal curve with a radius of 1791 ft lies 700 ft to the south and a 530 ft long horizontal curve with a radius of 2292 ft is 50 ft north. Buses stop in both directions. The sight distance analysis was completed at the supplied location on the roadway.

Figure 39: FNSBSD Richardson Highway at Salcha ES Drive bus stop location

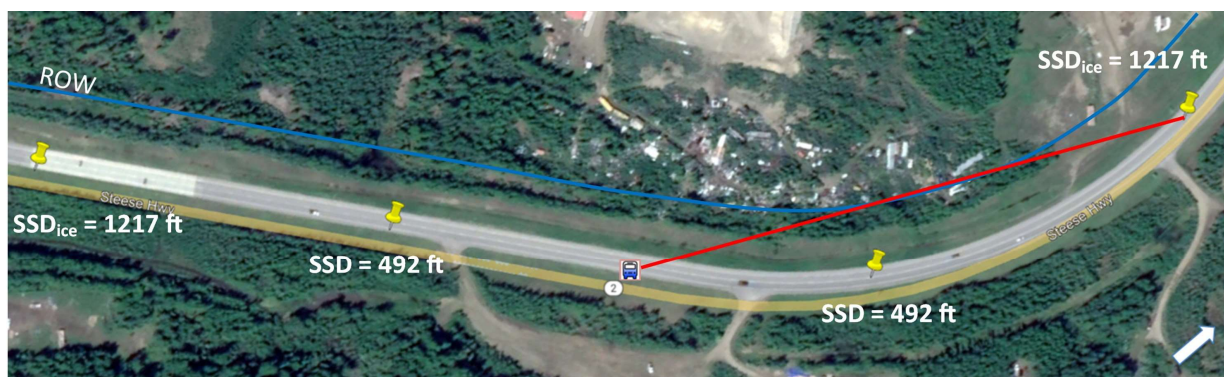
This stop is located approximately 150 ft from a 1473 ft long horizontal curve with a radius of 1146 ft. A bus stops in both directions on the roadway.

Figure 40: FNSBSD 2126 Steese Highway bus stop location

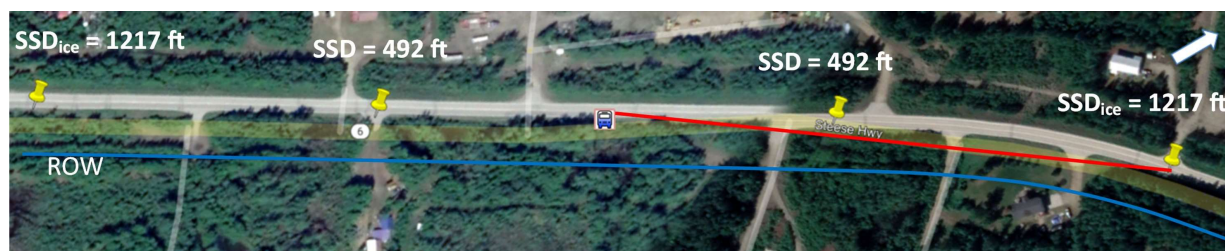
This stop is located approximately 600 ft south of a 750 ft long horizontal curve with a radius of 2600 ft. Buses stop on the roadway in both directions of travel.

Figure 41: FNSBSD 2303 Steese Highway bus stop location

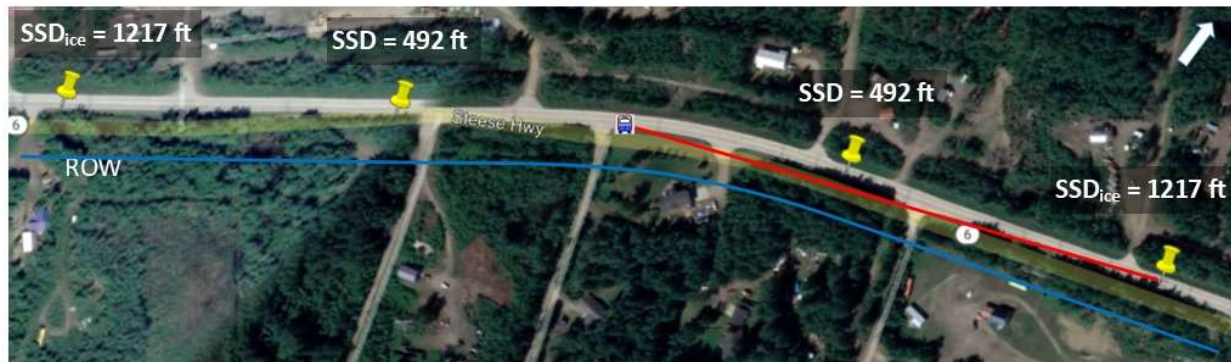
This stop is on a 750 ft long horizontal curve with a radius of 2600 ft. Buses stop on the roadway in both directions of travel.

Figure 42: FNSBSD 2324 Steese Highway bus stop location

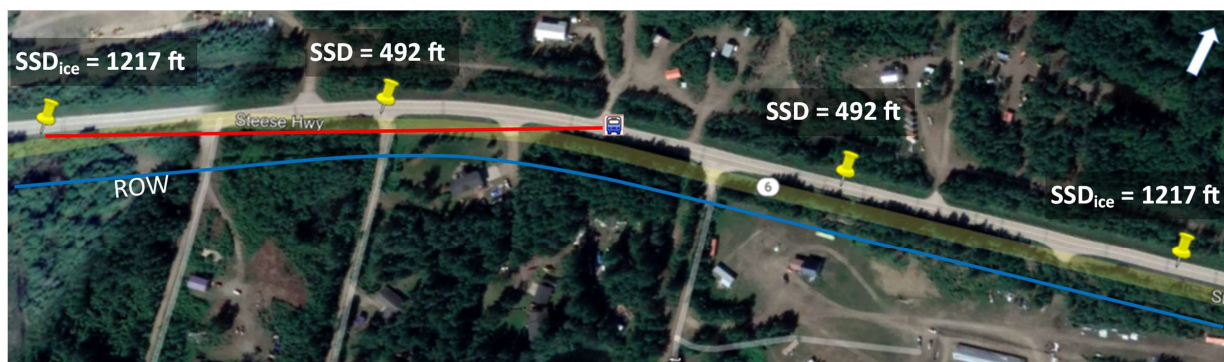
This stop is on a 750 ft long horizontal curve with a radius of 2600 ft. Buses stop on the roadway in both directions of travel.

Figure 43: FNSBSD 2343 Steese Highway bus stop location

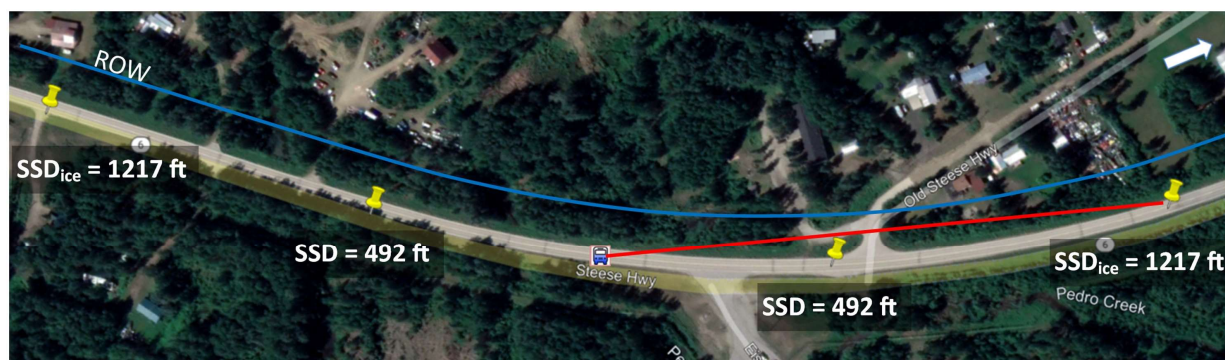
Figure 46: FNSBSD 2605 Steese Highway bus stop location

Milepost	Right of Way Width, ft	Traveled Direction	Speed Limit, mph	Horizontal Curve		Grade Values that are <-3% and >+3%	SSD, ft		Sight Distance Check
				Length, ft	Radius, ft		AASHTO	Ice	
13.5	200	north	55	1980	3300		492	1217	Horizontal
		south	55	1980	3300		492	1217	Horizontal

This location is on a 1980 ft long horizontal curve with a radius of 3300 ft. One bus stops in the southbound lane on the roadway. There is no northbound stop.

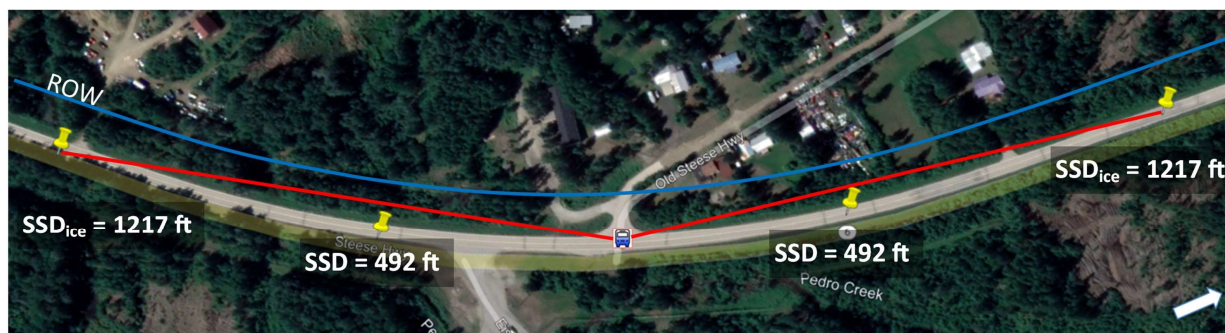
Figure 47: FNSBSD 2641 Steese Highway/Old Steese Highway bus stop location

Milepost	Right of Way Width, ft	Traveled Direction	Speed Limit, mph	Horizontal Curve		Grade Values that are <-3% and >+3%	SSD, ft		Sight Distance Check
				Length, ft	Radius, ft		AASHTO	Ice	
13.6	200	north	55	1980	3300		492	1217	Horizontal
		south	55	1980	3300		492	1217	Horizontal

This stop is located on a 1980 ft long horizontal curve with a radius of 3300 ft. Buses stop on the roadway in both directions of travel.
